A Survey of Zinc Concentrations in Industrial Stormwater Runoff

January 2006

Publication No. 06-03-009

By Steven Golding

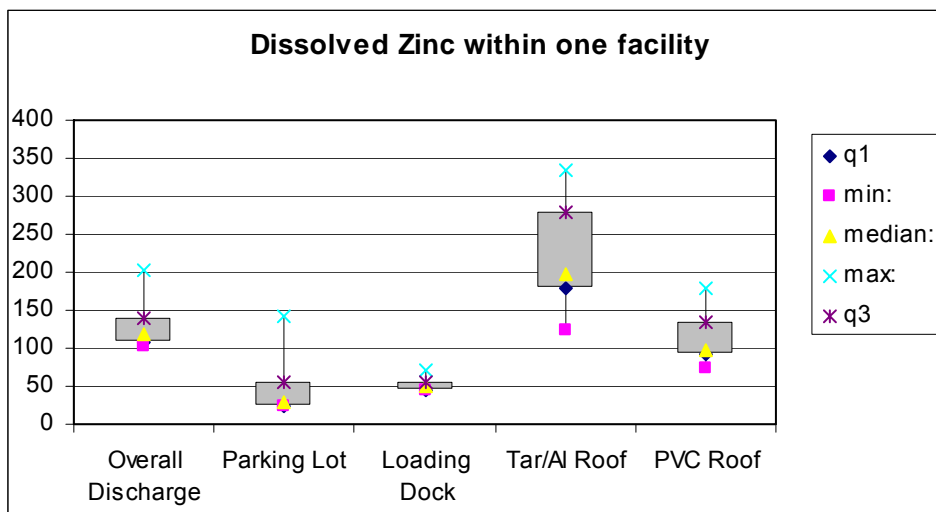
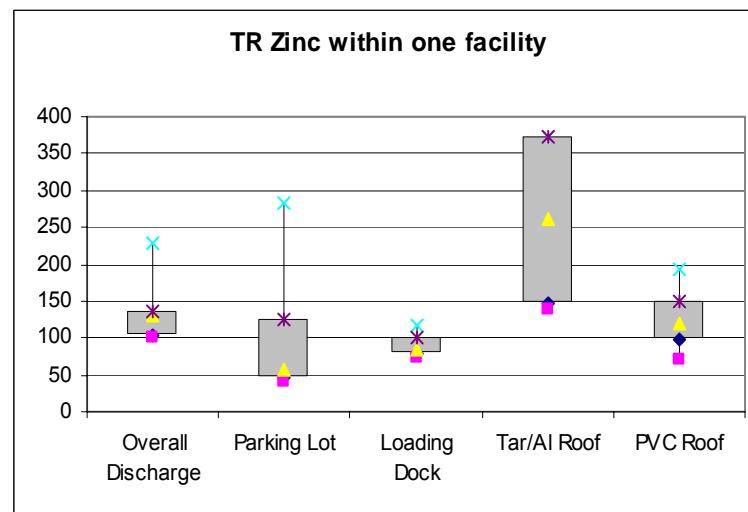
Samples of final stormwater discharge were drawn from the pooled water in the final catch basin at the edge of facility property, both by the facility for self-monitoring and in this monitoring study. The pooled water provided conditions for solid particles to settle out, as it did not appear to be flowing. This is consistent with the finding that the dissolved zinc fraction comprised most of the total zinc in the discharge sample (Table 5, Figure 1).

As Table 5 and Figure 1 show, zinc in roof runoff is mostly or all in the dissolved fraction. This is as expected, assuming zinc released from galvanized surfaces is in dissolved form. Parking areas and loading docks showed dissolved zinc being a portion of total recoverable (total) zinc. For the three days of loading dock sampling, 47%, 40%, and 34% of zinc were found in other than dissolved form (53%, 60%, and 66%, respectively, in dissolved form). The non-dissolved fractions at two Tree Top facility loading areas with tire dust evident were somewhat higher: 53% and 51% (Davis, 2005b). It may be that tire particles can be the major source of zinc particles (the portion of zinc not dissolved) in loading dock runoff samples. Further investigation would be needed to determine this.

Figure 1. Total and Dissolved Zinc Concentrations – Overall Facility Monitoring.
